IV. Facts

On or about February, 2008, the governing board of Pharr San Juan Alamo Independent School District (hereinafter, "Plaintiff" or "the District") authorized a preliminary investigation and assessment into the feasibility of upgrading and/or renovating existing structures at the District's Memorial Middle School campus in Pharr, Texas. One of the buildings considered for renovations and/or upgrades was a three-story main building, constructed in 1915 or 1918 with subsequent remodeling and/or additions in 1976 and 1986. Other buildings considered for renovation included a building used for textbook storage and a building used as a band hall, both originally constructed sometime in the 1940's.

Breach of Contract by Descon Defendants and Defendant ERO

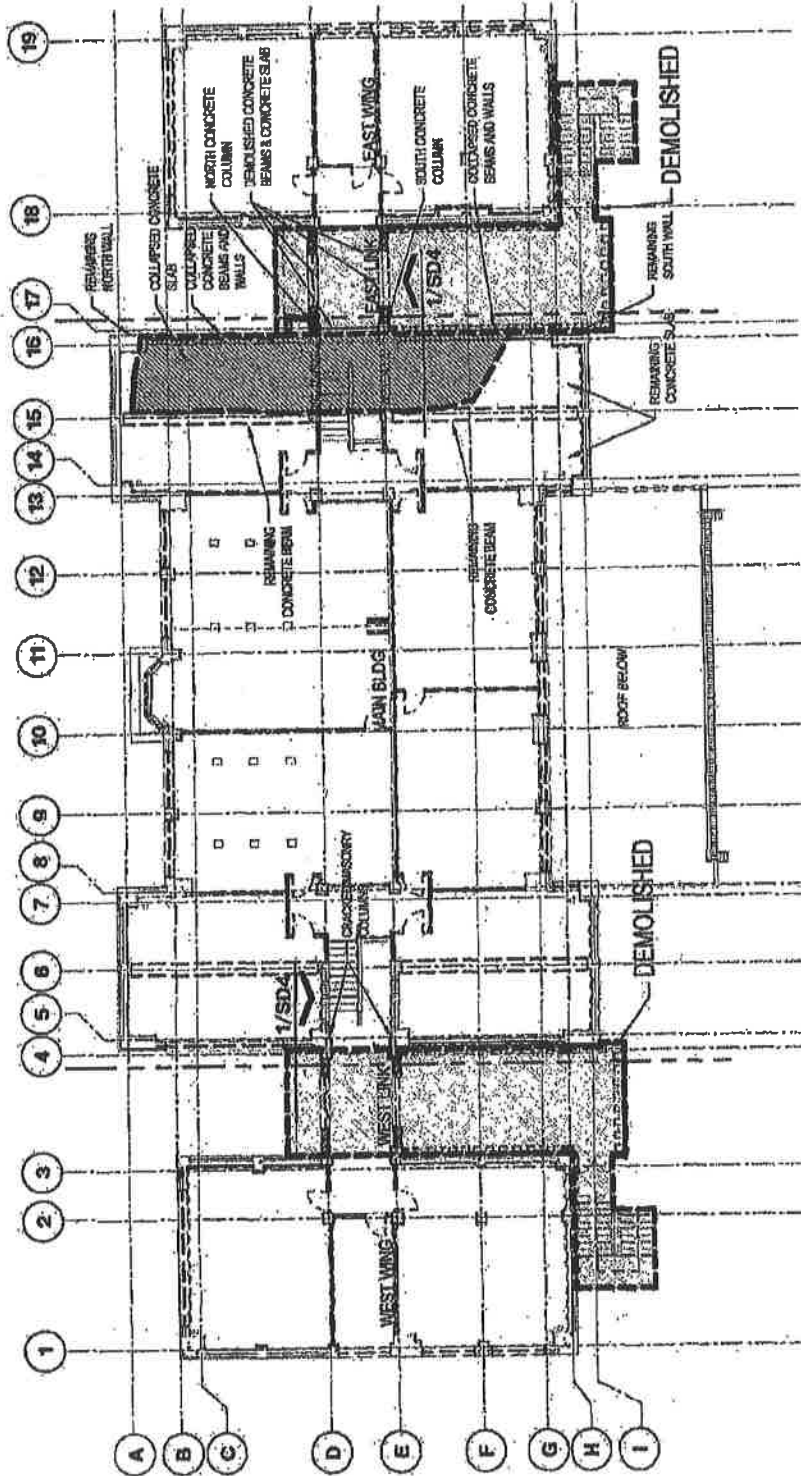
The East Link structure was completely demolished with the exception of some rebar spanning between the buildings. During the demolition of the link, an approximately 12 ft by 60 ft long section of the west side of Main Building was also damaged and collapsed. See plans on drawings SD2 and SD3 and Photos 1 to 17. The collapsed members include the concrete beams and slab at the second floor and roof, load bearing clay tile and brick veneer walls, exterior masonry columns, and concrete masonry unit infill at the wall opening. Part of the second floor and roof slab is still hanging by the rebar and the two wing walls at the north and south of the building are still remaining but have suffered severe damages and separation. The floor and roof beams had rotated and pulled out from the masonry walls, leaving a pocket in the walls. See Photos 2, 11, and 17. It appears that the collapse stops at the first interior beam along Grid 15. See plans on drawing SD2 and SD3.

It is evident that the collapse of the second floor and roof slab and beams are result of structural failure of the columns and load bearing walls. The initial cause of failure of the vertical members is not as apparent and could be a combination of several factors. The sequence of events starts with the north concrete column supporting the East Link structure being forced to displace outward during the process of demolition. The lack of expansion joint between this concrete column and the masonry column supporting the Main Building allowed the two columns to bond together. The outward movement of the concrete column creates a lateral force on the masonry column. The hollow and unreinforced masonry column is subjected to axial and lateral force and does not take long to buckle and collapse. With the collapse of the first masonry column, the adjacent clay tile and brick wall panel starts to fail and move outward because there is no connection between the wall and the slab. As a result of the failure of the columns and

wall, the slab and concrete beams above are losing support and start to deflect and rotate. At the same time, the weight of the slab and wall above starts to shift to the other masonry column and overloads the column and wall panel. When the beams lose the center supports, the slab starts to deflect downward under its own weight and suffers both shear and flexural failures. When the second floor beam and slab fails the load bearing wall supporting the roof structure starts to fall, causing failure in the roof slab similar to the floor slab. The structure finally reaches equilibrium when the slab collapsed and detached from the end walls and the beam pulls out from the masonry pockets.

The origin of the force that starts the failure of the north masonry column is related to the demolition means and methods. It could be excessive force from the high impact chipping hammer working on the concrete frame. As mentioned previously, the collapse of the structure is probably due to a combination of several factors: Contractor's means and methods during the demolition and lack of protection of the existing structure, issues related to the original design and construction, and pre-existing conditions. The building was designed primarily as concrete frame structure except clay tile wall was designed as load bearing wall to support the concrete slab and beams at the exterior of the building. Individual columns supporting the exterior concrete beams are made of clay tiles or bricks, forming a box shape vertical structure. There is no concrete or reinforcing inside the columns and there is no connection between the concrete beams and the clay tile columns other than a beam pocket. As a result of the lack of restraint at the top of the column any significant lateral force acting on the column will destabilize the column. The construction method of the concrete columns supporting the Links also contributes to the failure of the building. The new concrete columns were cast against the existing masonry walls and columns without expansion joint and the columns were plastered together and creating a bond between them. This condition does not allow the columns to move independently and allows force transfer between them; and as a result, impact from the chipping hammer hitting the concrete column in the Link could have created distress in the masonry column in the Main Building. Another factor that contributes to the collapse of the structure is the pre-existing conditions of the clay tile walls and masonry columns. Pre-existing conditions include cracks and spallings in the clay tiles and masonry which would have weakened the structure and reduced the load carrying capacity.

In conclusion, it is our opinion that the collapse of the structure is caused by demolition means and methods, and to a lesser degree the pre-existing conditions and the design and construction of the original buildings.

We recommend that the partially collapsed slab be removed to the face of the beams at the first interior grid line 15. See plan on drawing SD2. The remaining clay tile and masonry walls at the north and south of the building shall be removed to the west of grid 15. New steel structure shall be installed to replace the collapsed slab. Install concrete masonry unit (CMU) wall to the inside of existing wall along grid line A and grid line H and between grid lines 13 and 15 and turn the corners to the masonry columns at B-13
